## LNER vans for the GE Section

### *D.86 General Van and D.87 Milk Van*

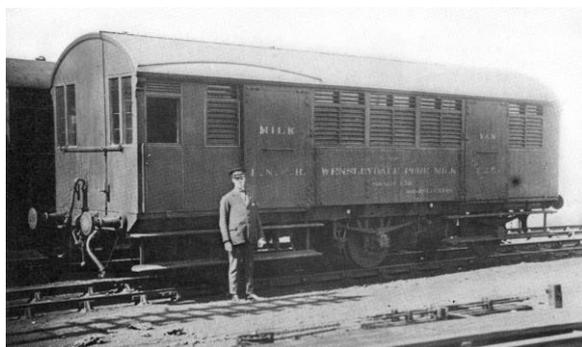
*The NER's milk van of 1908 for Wensleydale, precursor to D.86 and D.87, seen in 1926*

The main changes for D.86 were reduction to four wheels, elimination of the guard's compartment, allowing a third sliding door to be added, and addition of ventilation grilles on the ends, just above the buffers, a common device at the time. Dual braking was fitted and a through steam heat pipe. It was, after all, designed for use with passenger trains and overnight runs carrying fruit and vegetables all over the country, including on the LNER, the West Riding, Liverpool, the North East, and Scotland. The LMS area was reached via Peterborough and the GWR via Acton. I suspect that traffic to the SR was lower and was carted across London. Novel features which added complexity were on the sliding doors: most prominent was the GER-style recessed locking handle. The second was the pull handle, usually placed horizontally in the middle of the door, but here it was mounted vertically, also in a recess. Both were probably to maximise the width of a body fitted with external sliding doors inside the loading gauge, which at the time required a maximum width of 9ft.

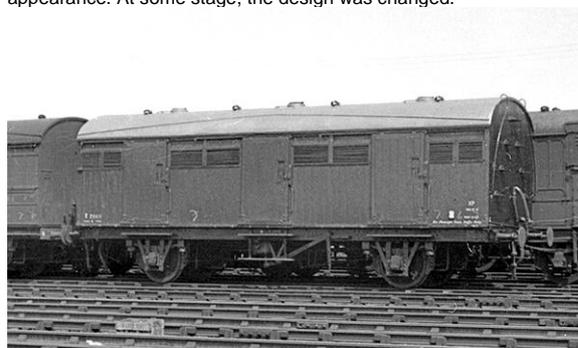
*D.86*

The drawings on Diagrams 86 and 87 look the same, yet service photographs show different bodies. The first version had a complete run of 6 toplights with grilles underneath. The second omitted toplights in the middle so that the grilles were higher, giving a staggered appearance. At some stage, the design was changed.

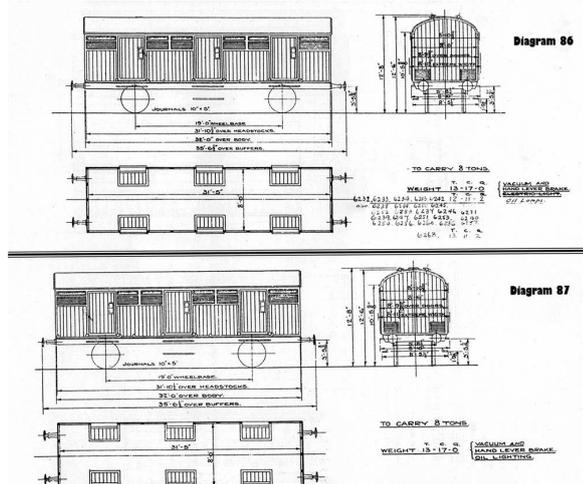
A later issue of this Diagram, shown above, with D.87 beneath (enlarged in Fig.2 below) is reproduced in Michael Harris's "LNER Standard Gresley Carriages", Mallard Books, 1998, on p.84. The annotations were expanded and underneath the lower weight of 12-11-2, individual running numbers were written - but not in a series as you might expect but randomly from among the first ones built - between 6231-60. There are several gaps and it gives the impression that electric lighting was originally fitted, and then removed, the running numbers being added as the vans were recalled and passed through the works. No further numbers are quoted, and there is no such change for D.87, whose heavier weight could be explained by the fitting of a more durable floor (some companies used concrete) to withstand the wear and tear of heavy steel churns, and ease of washing out spillages.

In one of the early issues for D.86 (but clearly not the very first) the annotation "Electric lighting" was crossed out and "Oil lamps" written underneath. A weight of 13-17-0 was quoted with a lower weight added underneath of "12-11-2" with an asterisk, apparently for the oil-lit version.

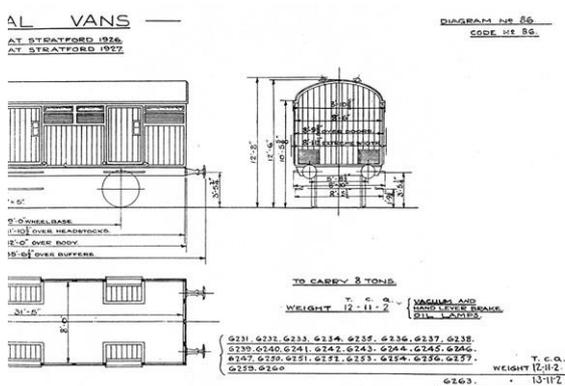
On my issue of D.86 (shown above, and enlarged below) the annotations are different again and no longer show the original weight, only the lower one of 12-11-2 and, underneath, a list of running numbers in numerical order. Again there are gaps, which tally with the Harris version of the Diagram, but fewer of them. This version had been issued when conversion was almost complete. Standing apart among this is No 6263 which is quoted as having an in-between weight of 13-11-2. The reason is not known. It is, however, clear that electric lighting was fitted to the first thirty built in the sequence 6231-6260, and that from early 1927, construction had oil lighting, and the first 30 were retro-converted to the same.

Diagram 87 was not altered at any stage but the drawing, although apparently identical to D.86, has one small difference: the end

elevation shows oil lamps on the roof. The most likely explanation is that the Milk van, serving most of the time in daylight, was never intended to have electric lighting.

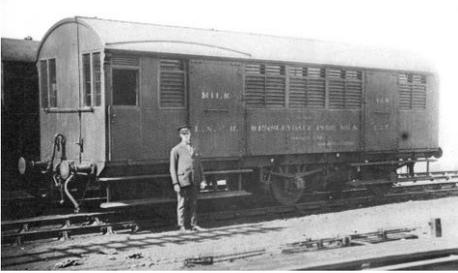
1. The NER's milk van of 1908 for Wensleydale, precursor to D.86 and D.87 (below), seen in 1926.

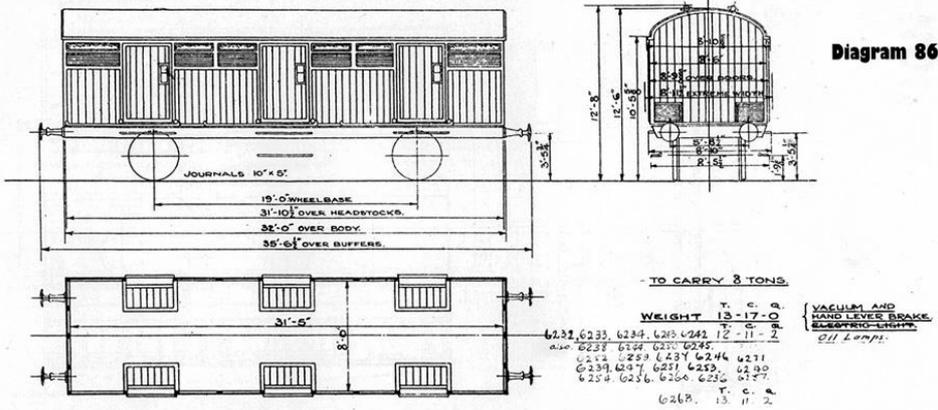
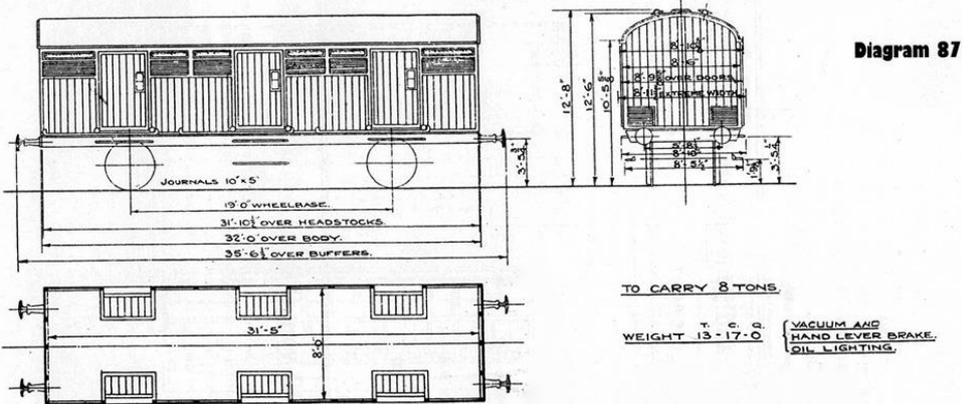
2. Diagrams per Michael Harris.

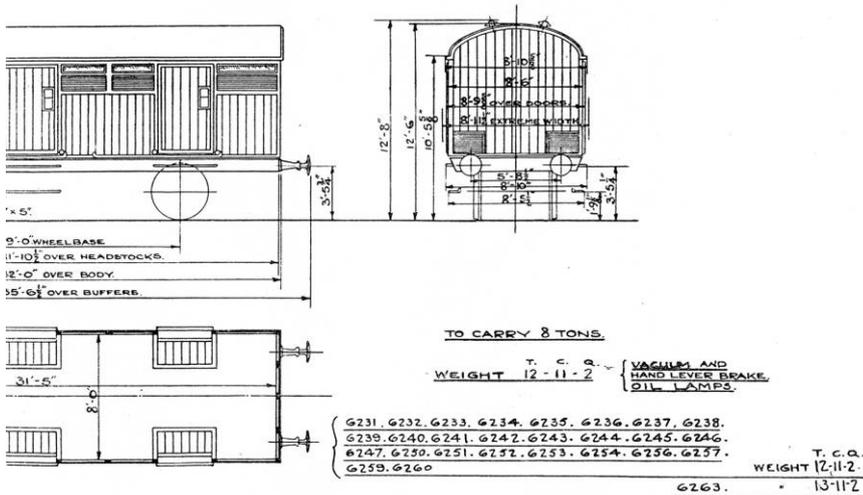
3. My copy of D.86. No 6263 is an oddball, between the final weights of D.86 and D.87.

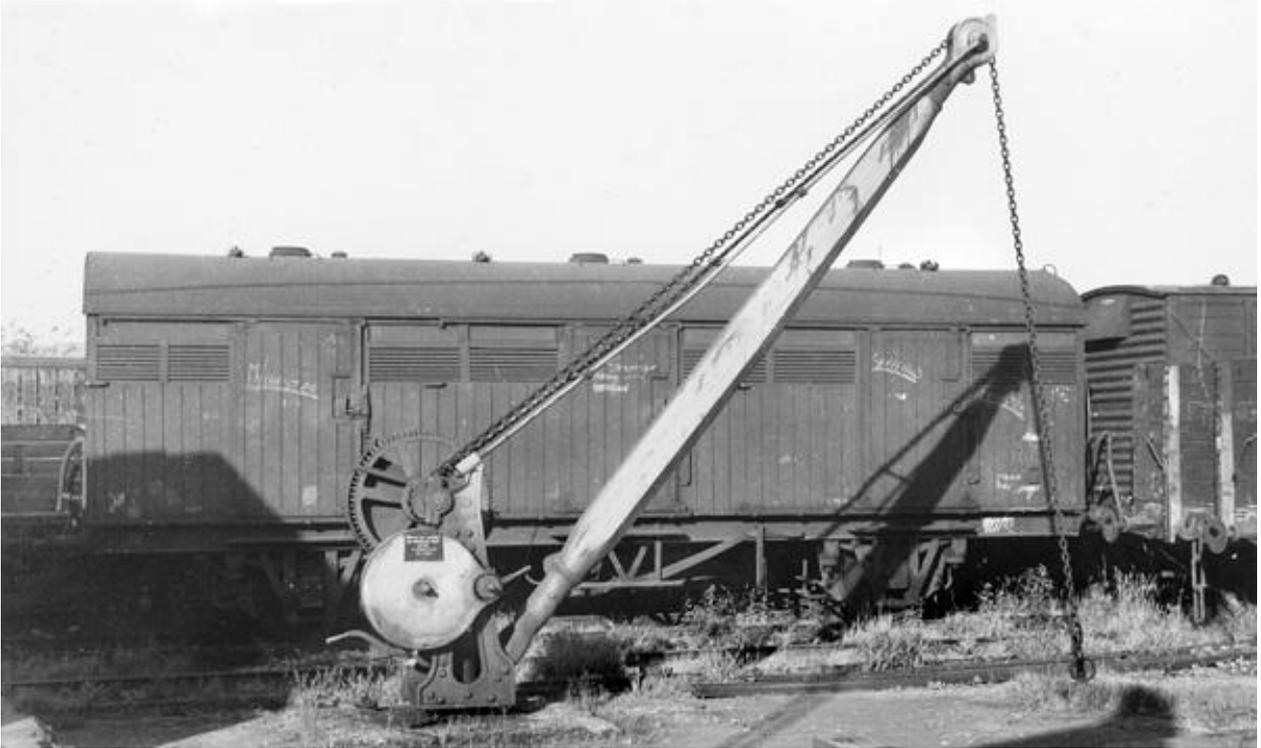
4. 1955 - Behind the goods yard crane at Godley is a D.86 in original condition. Still dual-braked and carrying the oil lamp bung holders. The latter are on the end steps side with the hinge on the oil lamp top on the other side. Date based on solebar marking in chalk or whitewash of 17/7/55. Photo: Author's collection.

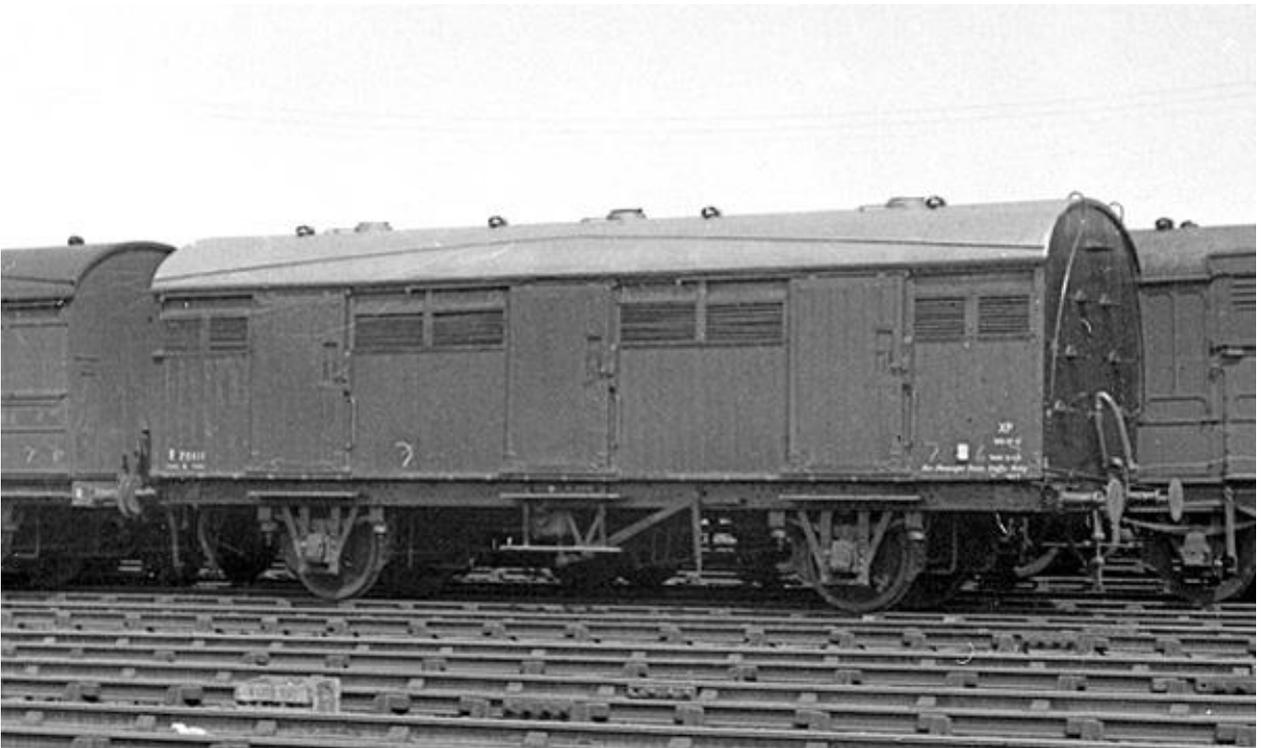
5. 1956 - D.86 No E70111 (ex-6263) ex-works. Bung holders and Westinghouse brake removed. Stratford-style rain strip. Image slightly soft. Photo: Denis Seabrook, now HMRS ADV720.

The only two pictures found so far where the numbers can be read show 6250 and E70111 (6243) from the middle of D.86. A useful indicator is a photo taken at Askrigg in 1952 where one of the later bodied vans was being used to carry milk churns. This would tally with D.87 Milk Van and suggests that the design was changed when construction of D.87 started in 1927. There are three possible reasons why.

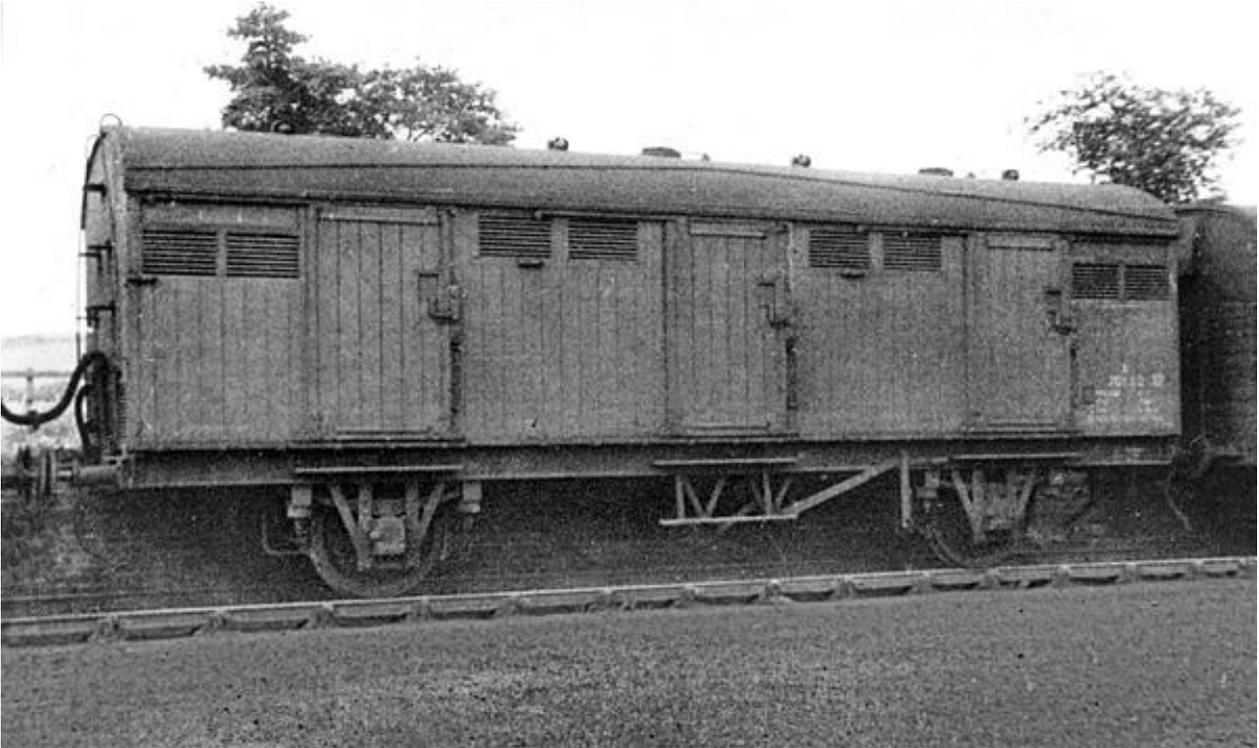
6. c1950 - A rare and undated portrait of a D.87 van from c1950. The last two digits are alas unreadable. It is still dual braked with through steam heat pipe, oil lamp tops and barely visible from this angle, bung holders. Still with Stratford style rain strip. Photo: Dan Pinnock collection.

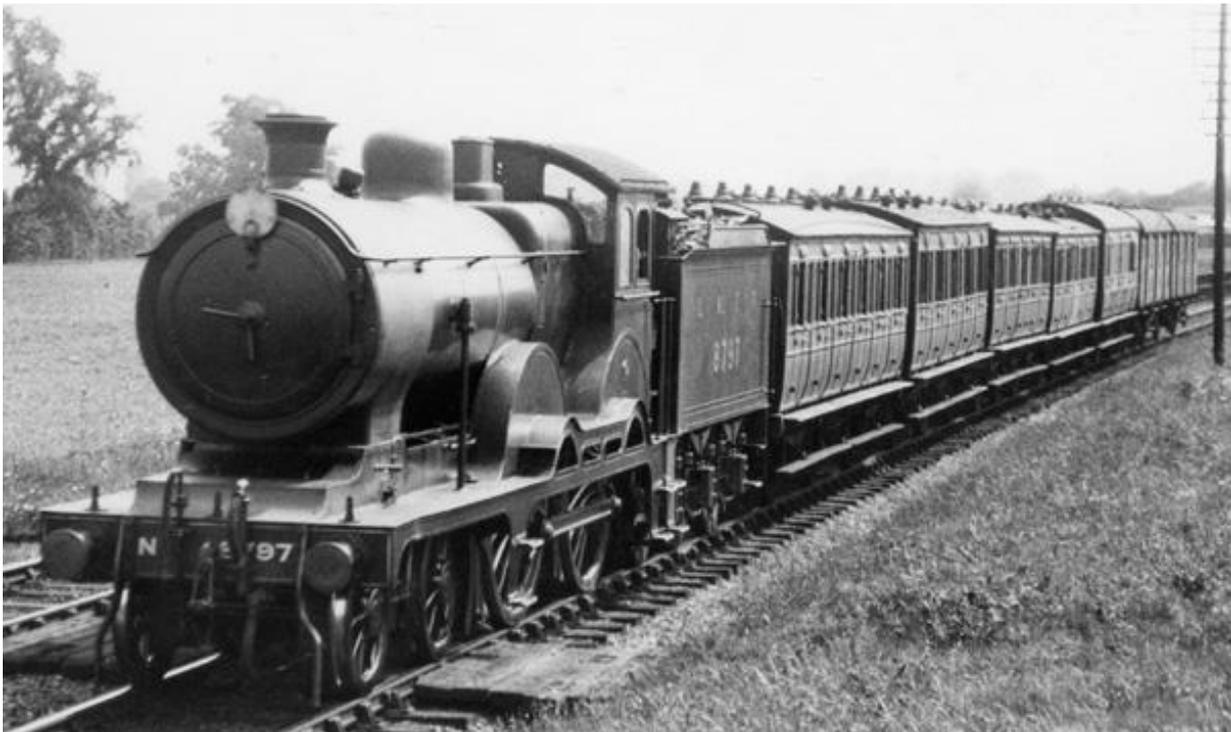
9. D16 8797 near Littlebury in the late 1920s when the D.86 General Vans would have been quite new. The Ordinary Passenger train of 6w carriages (possibly T, T, C, CL, B) has two of the vans on the rear, both fitted with oil lighting. This is a slight crop, the whole view shows passing trains. Photo: Author's collection.

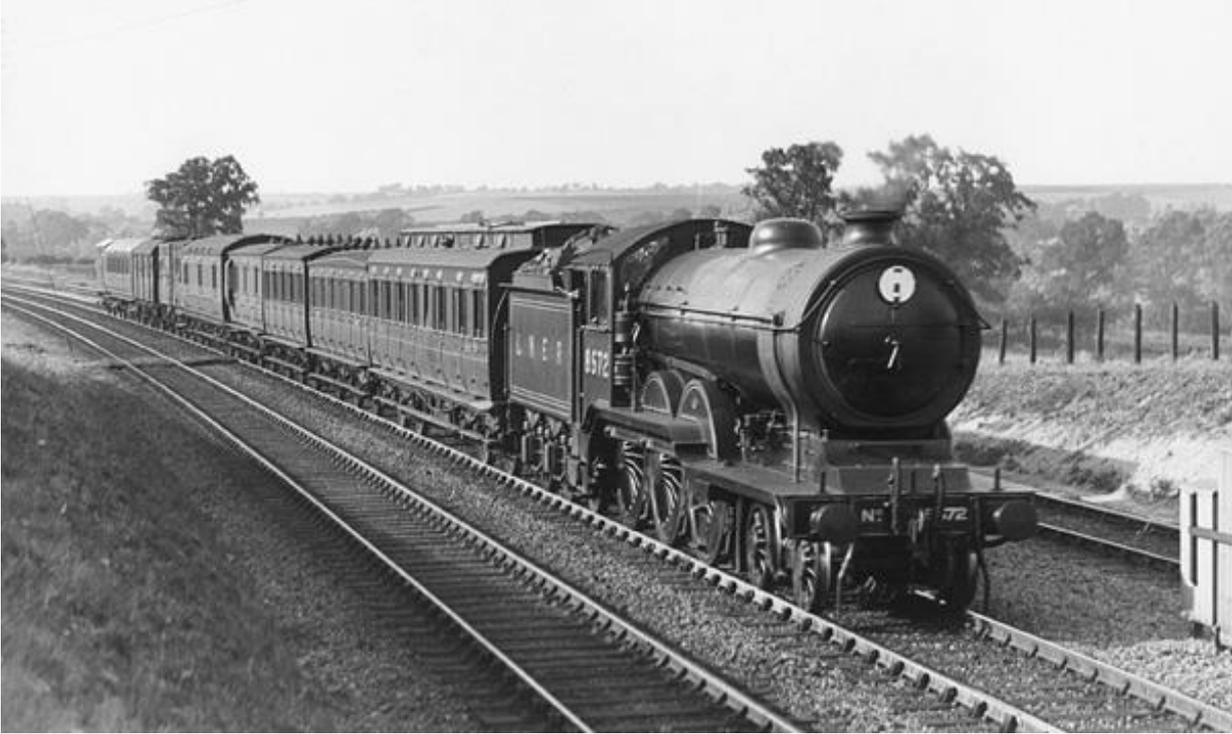
10. B12 No 8572 near Littlebury with an Up train, 27th July 1934. Looks like an Ordinary 4-set with vans on the rear, some may be an ECS movement. With a D.86 oil-lit van in the middle. Photo: E.R. Wethersett, author's collection.

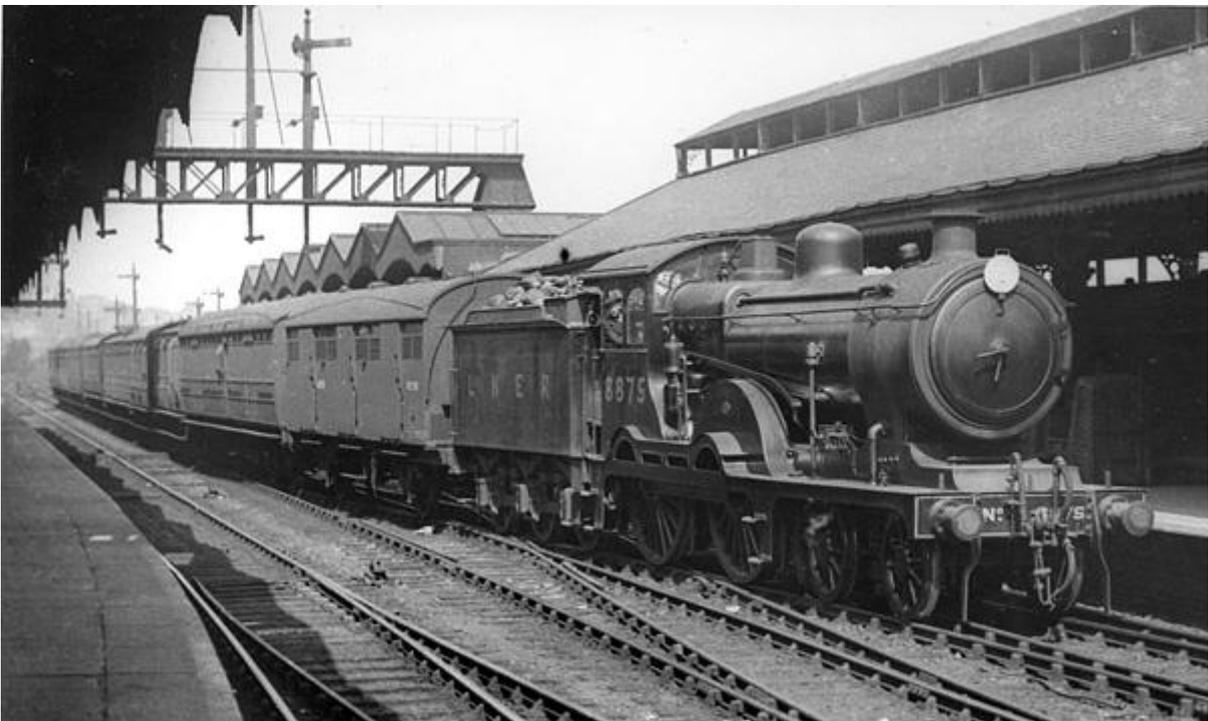
11. D16 No 8875 arrives at Ipswich sometime in the 1930s with an Ordinary Passenger train of one bogie and four 6w carriages. The oil-lit D.86 van carries white lettering in the middle of the body and the number 6250 is legible. Behind it is a 52'6" BG and an ex-GER 32ft 6w passenger brake van. Photo: Photomatic.

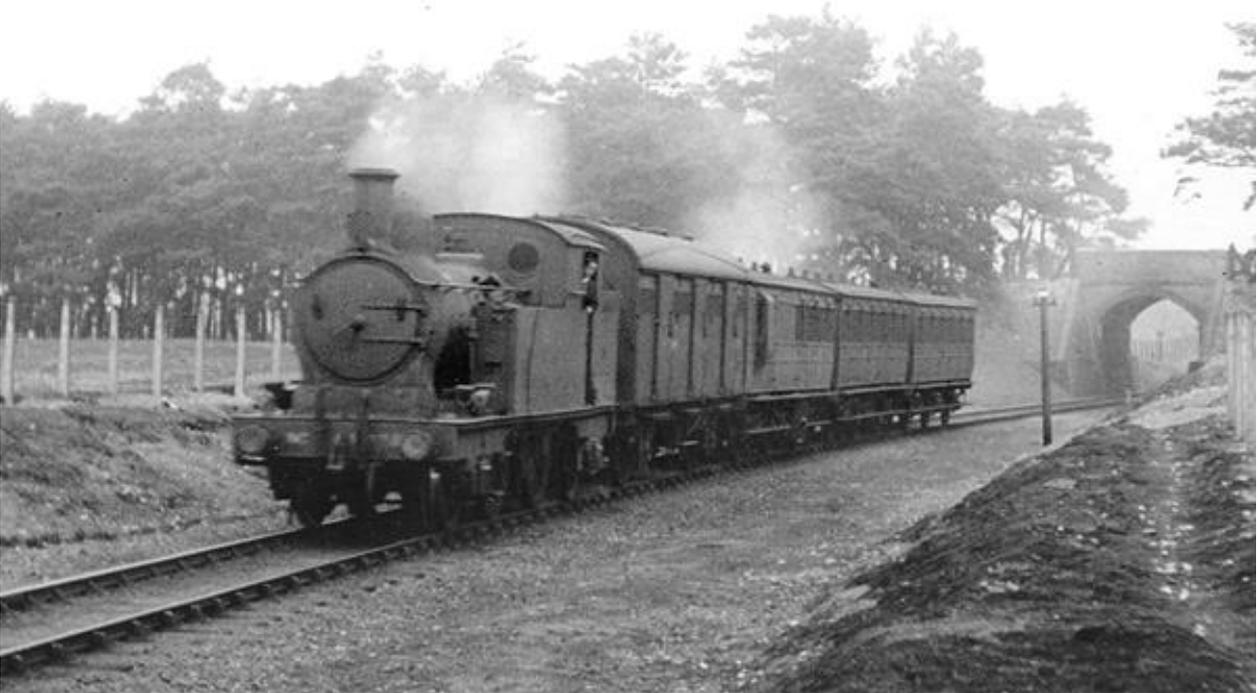
12. F3 No 8075 with 3 pm Thetford-Bury near Burnham. 27th February 1937. A poor quality image but an oil-lit D.86 with Stratford rain strip is evident. Photo: SLS.

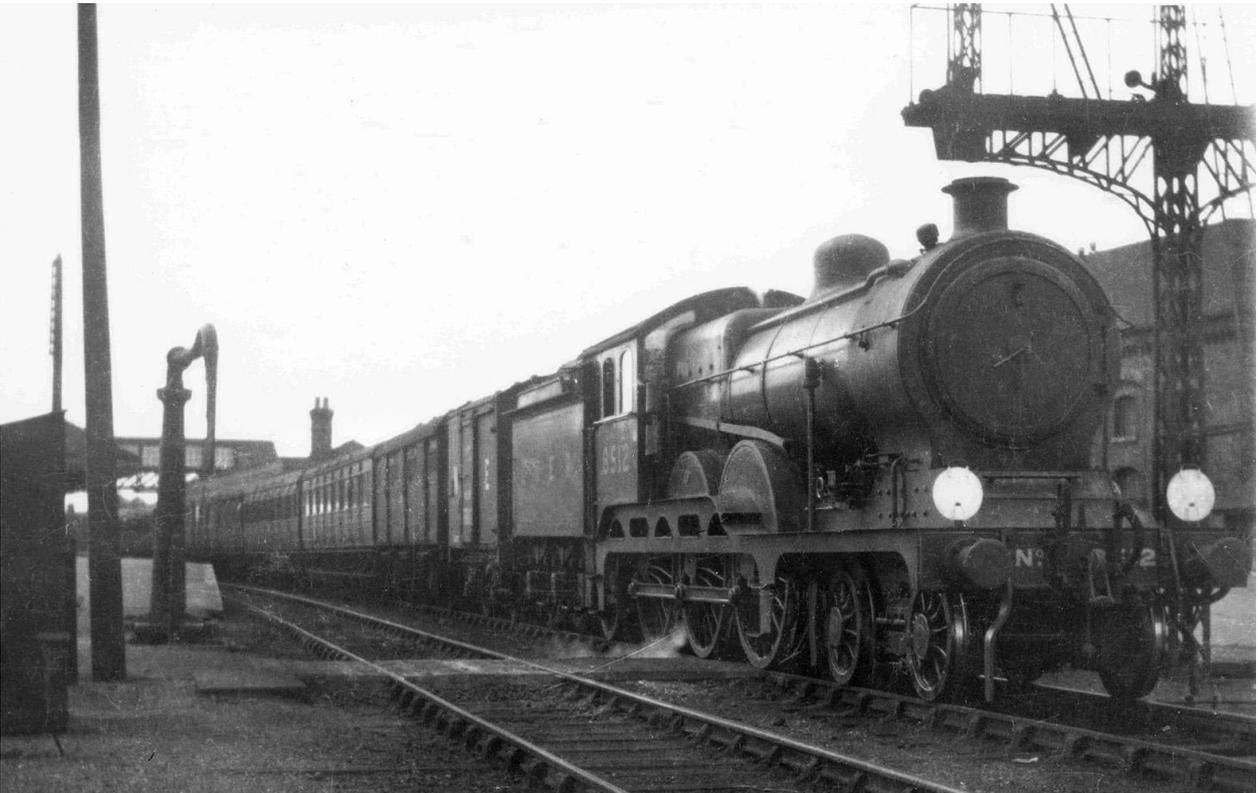
13. B12 No 8512 at Spalding with an express, date unknown. It's not the sharpest picture and I have tried to balance the tones and clear up damage to the negative because, at the head of the train is an LNER "FRUIT" van and a D.86. Both are clearly in service for the traffic they were intended for. Photo: SLS No 2281.

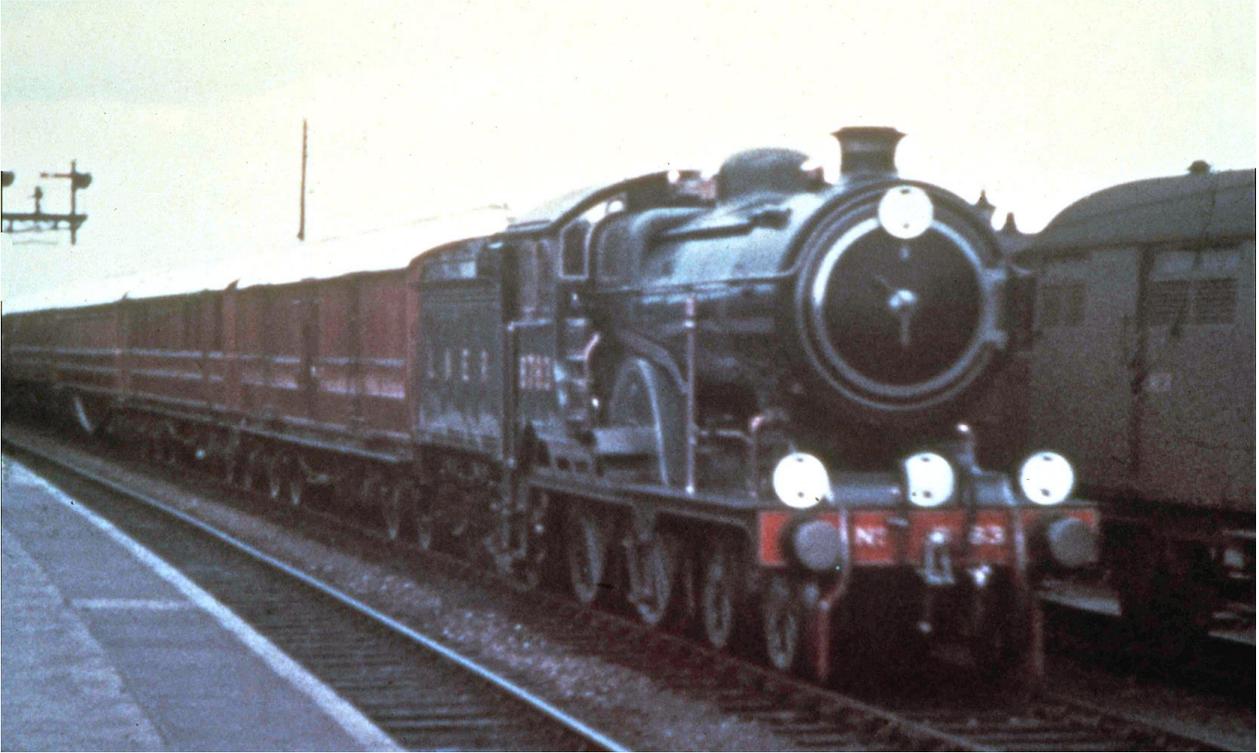
14. D16 No 8783 is passing through Cambridge with the Down Royal Train in 1938. This is a Colour Rail still from a cine film which I have remounted to show the maximum on the right hand side, losing part of the train on the LHS, and corrected the tones. I can't fix the blurring, alas, and you can't rely on an accurate rendition of the colours, but it's evident that the D.86 van, which is fairly clean, is a relatively dark shade of brown. And what appears to be the legend "LNER" has not been applied on the door but on the body to the right. Photo: based on Colour Rail NE71.

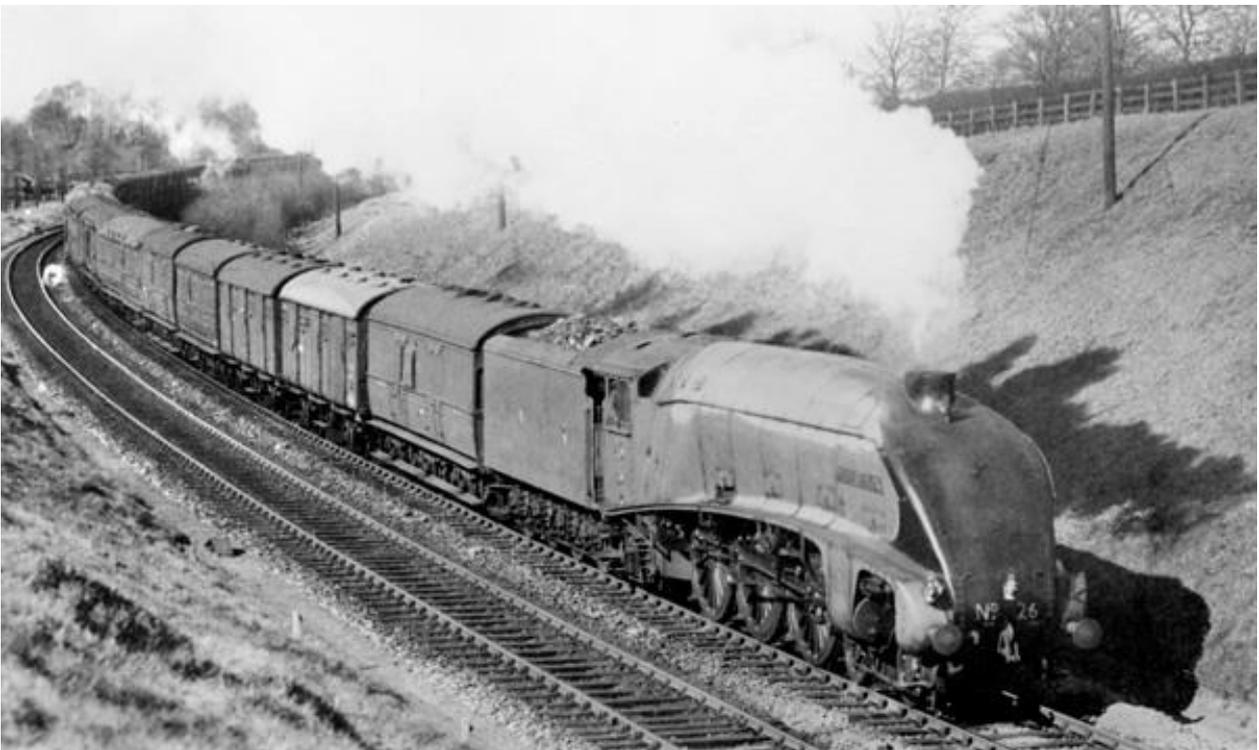
15. c1947 with No 26 *Miles Beevor* at Chaloner's Whin and an Up parcels. With two oil-lit D.86 vans and an electrically lit D.120. Photo: Author's collection.

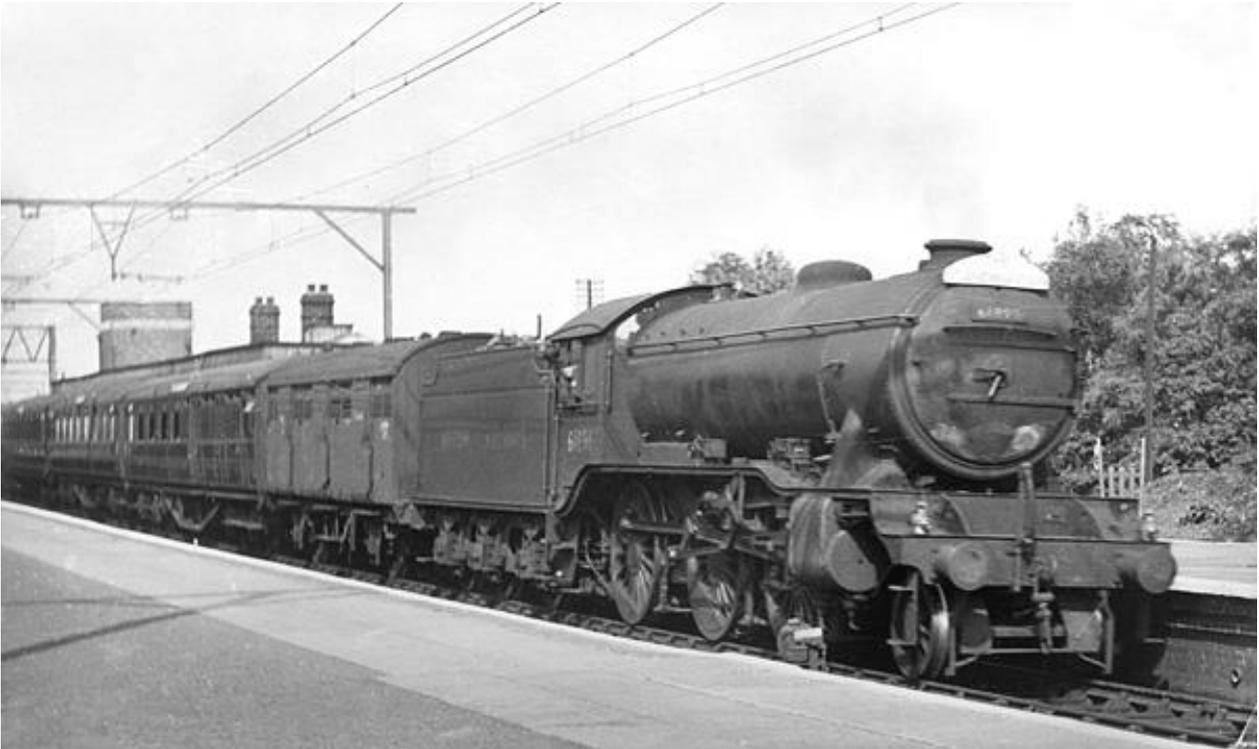
16. 20 Aug 1949, K3 61896 at Shenfield with the Up "Scandinavian". D.86 with oil lighting and Stratford rain strip, carrying fruit and veg or passengers' luggage? Photo: R.C.J. Day.

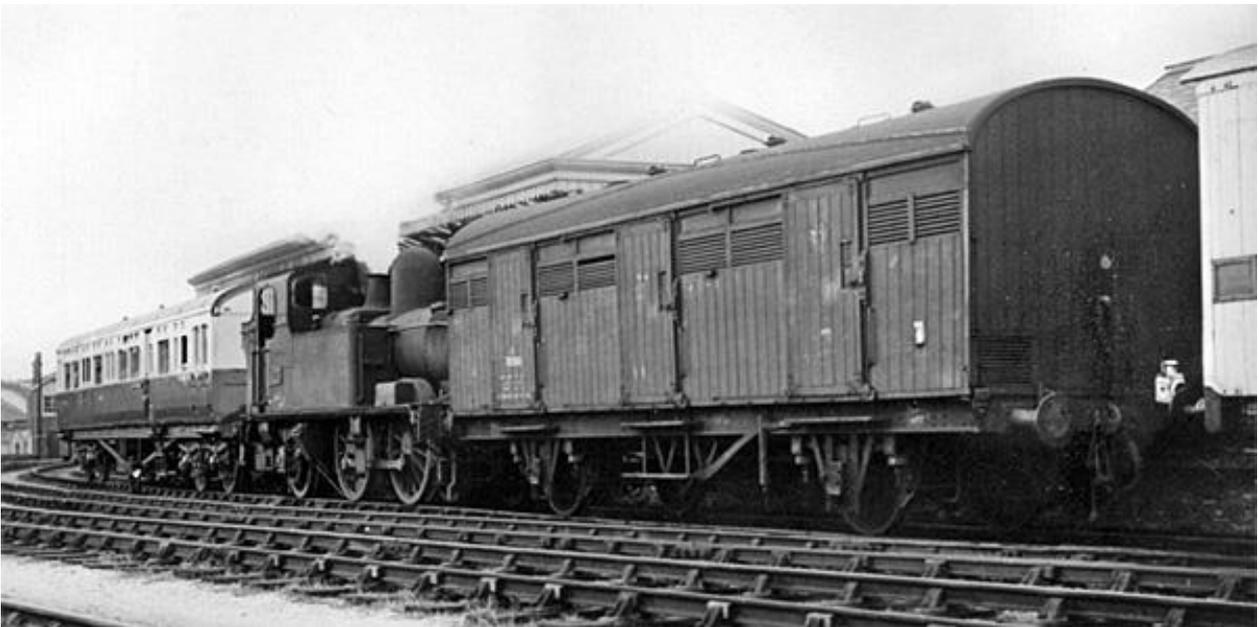
17. A scene at Brixham station in August 1950 with a 14xx propelling an auto coach and pulling what may be a through oil-lit D.86 van from East Anglia. Photo: Photographer unknown.

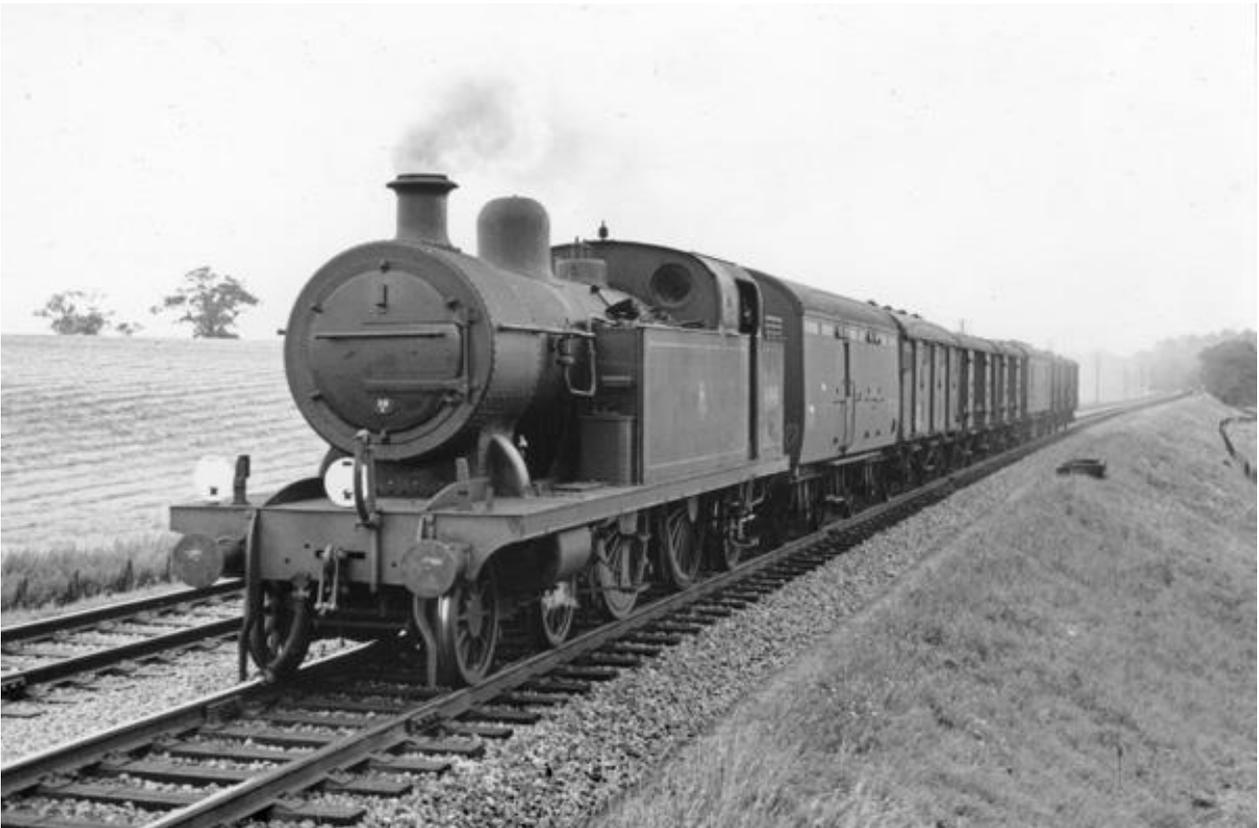
19. "Tilbury Tank" No 41949 near Bentley in the 1950s with a parcels train including, behind the Thompson 6w van, an oil-lit D.87. Once again, the rain strip has been changed to the curved type: other pictures from this period show both types. Photo: Author's collection.
